Deepwater Horizon Accident Investigation Report

September 8, 2010

Executive Summary

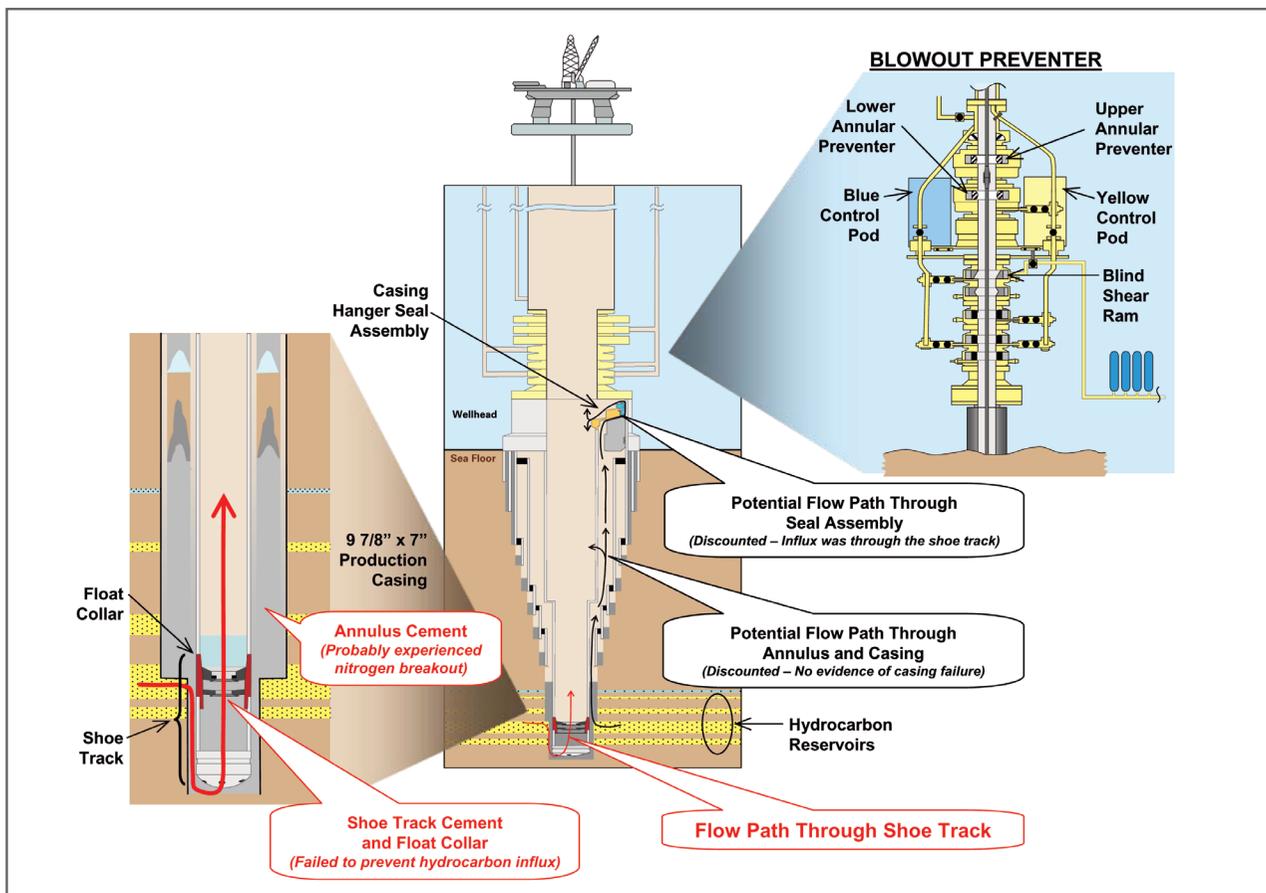
Figure 1. Macondo Well.

- 1 The annulus cement barrier did not isolate the hydrocarbons.** The day before the accident, cement had been pumped down the production casing and up into the wellbore annulus to prevent hydrocarbons from entering the wellbore from the reservoir. The annulus cement that was placed across the main hydrocarbon zone was a light, nitrified foam cement slurry. This annulus cement probably experienced nitrogen breakout and migration, allowing hydrocarbons to enter the wellbore annulus. *The investigation team concluded that there were weaknesses in cement design and testing, quality assurance and risk assessment.*

- 2 The shoe track barriers did not isolate the hydrocarbons.** Having entered the wellbore annulus, hydrocarbons passed down the wellbore and entered the 9 7/8 in. x 7 in. production casing through the shoe track, installed in the bottom of the casing. Flow entered into the casing rather than the casing annulus. For this to happen, both barriers in the shoe track must have failed to prevent hydrocarbon entry into the production casing. The first barrier was the cement in the shoe track, and the second was the float collar, a device at the top of the shoe track designed to prevent fluid ingress into the casing. *The investigation team concluded that hydrocarbon ingress was through the shoe track, rather than through a failure in the production casing itself or up the wellbore annulus and through the casing hanger seal assembly. The investigation team has identified potential failure modes that could explain how the shoe track cement and the float collar allowed hydrocarbon ingress into the production casing.*
